Observation of arc fault in aeronautical conditions

Mohamed Boukhelifa, Romaric Landfried, Thomas Klonowski, Thierry Leblanc, Philippe Teste. Observation of arc fault in aeronautical conditions. MEA 2021 More Electric Aircraft, 3AF & SEE, Oct 2021, Bordeaux, France. pp.P2.10. hal-03451497

Observation of the phase before DC arc fault apparition in wet conditions

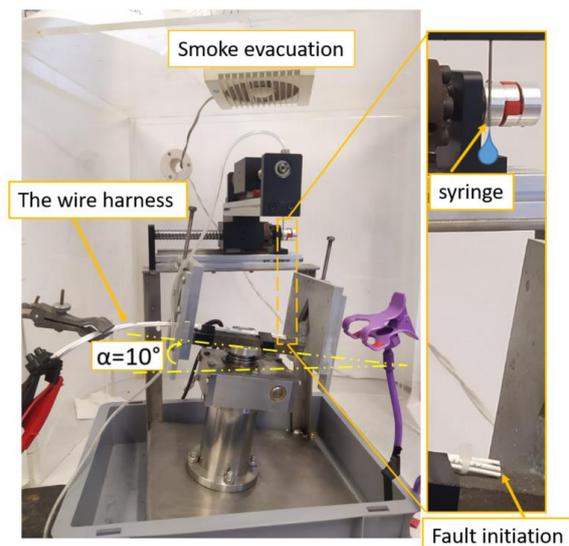
Fig. 1: photograph of the mechanical experimental device for the study of wet "arc tracking".

The experimental bench is presented in fig. 1. It's a wet arc tracking test bench, based on the initiation of a fault to wiring harness by a contaminating fluid (in our case salt water with controlled salinity, namely 30g / L) and corresponds to the recommendations of the AC standard (FprEN 3475-605). The polarity of the sample adjusted for direct current tests is described in figures 2. b and 2. c.

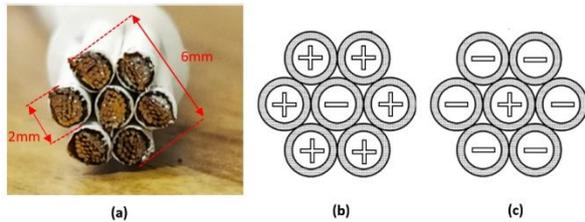
Fig. 2: a: photograph of harness with seven aeronautical cables, b: negative polarity, c: positive polarity

The reference cable used in the tests is: ASNE0261 CF 14, Polyimide tape – white, ASNE (Airbus) High Temperature Wire & Cable. Voltage Rating: 600 V. Temperature Ratings: -55°C to +200°C, used in the European aerospace industry [4].

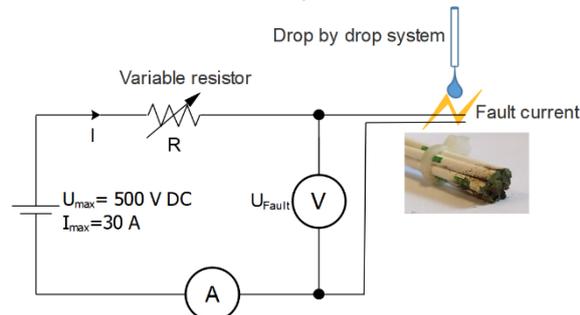
Fig. 3: electrical diagram of the experimental device used for the study of wet arc tracking with a purely resistive load.

The fault is in series with the power supply and is connected with the second part of the circuit.

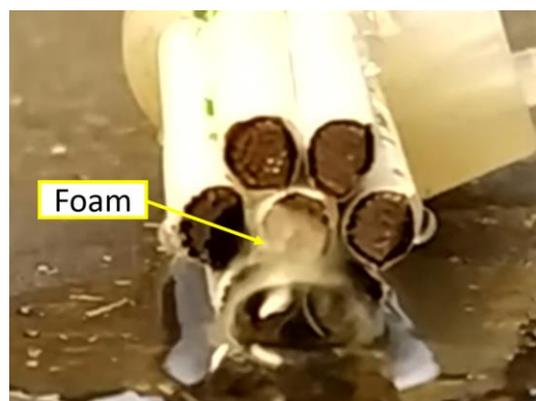
Fig. 4: first step of crackle: appearance of a current in the defect

- "crackling" noise (hence its name) in an audible frequency range (20 Hz-20 kHz), the voltage of the fault equals to supply voltage.
- Appearance of a sort of foam due to the fault current that is presented in the fig. 4.
- Appearance of luminous points on the surface of the insulation of the central cable (either anode or cathode) fig. 5 and 6.
- Appearance of luminous points on the surface of the anode core which is presented in fig. 7.

- ❖ **First step:** start of the current flow in connection with the drop of salt water without luminous phenomenon (fig. 4), it is characterized by slow evaporation of the contaminating liquid and the appearance of a sort of "foam" on the fault. The average value of power dissipated in the fault around to 1 W.

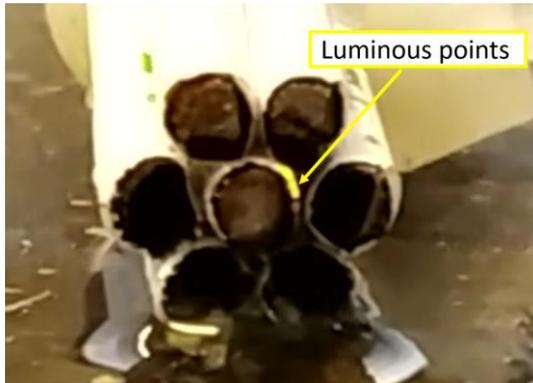
Fig. 5: second step of crackle: appearance of light points,

- ❖ **Second step:** appearance of luminous points / increase in the number of luminous points (fig. 5 and 6). The end of this stage is distinguished by the appearance of a ring shape formed by the luminous points on the surface of the insulation of the center cable. This is accompanied by further disturbances of electrical signals with current peaks that can

reach amps in intensity. The average value of power dissipated in the fault around to 6 W.

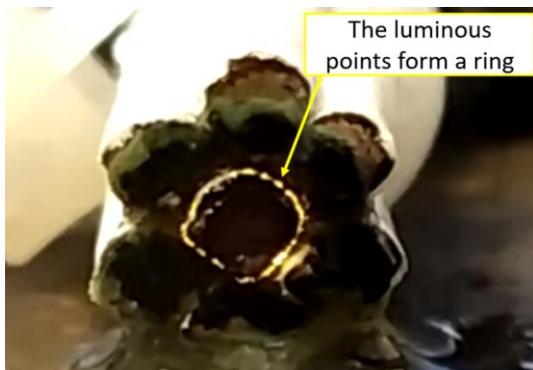
Fig. 6: second step of crackle (evolution): increase in the number of luminous points

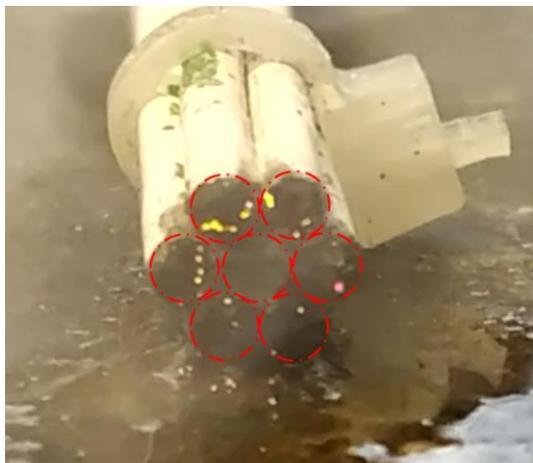
Fig. 7: third step of crackle: appearance of luminous points on the surface of the anode core and degradation of the anode.

Third step: appearance of luminous points on the surface of the anode core, a higher fault current intensity than for the other steps with current peaks of the order of magnitude up to a few amps. This step is also characterized by decomposition of the anode. (fig. 7), and this is the step that causes more degradation on the wire harness due to the decomposition of anode core like in the fig. 8, The average value of power dissipated in the fault around to 10 W.

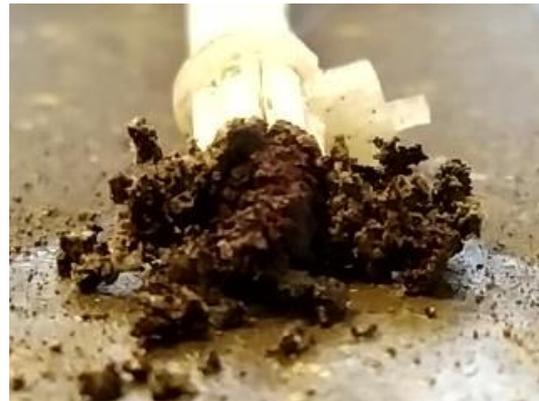
fig. 8: damage caused by the crackle on the harness

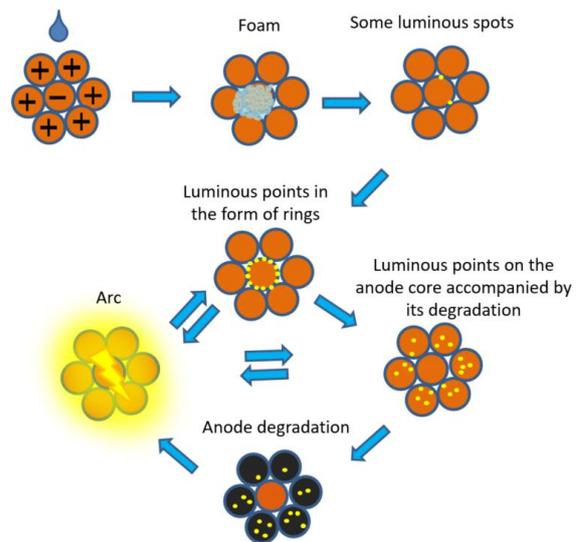
Fig. 12: summary diagram of the main stages in the development of crackle phase

The chronological evolution of the fault depend mainly on the level of voltage. The figure below synthesizes the various possible evolutions that we have observed among the various phenomena that may occur.

The open circuit has been very rarely observed. It is caused by the decomposition of the anode core (during the third step of crackle phase) in the case of positive polarity.
